# Flumendosa Arch Dam

## Rehabilitation of the structure by epoxy grouting

**Flumendosa Arch Dam  
Rehabilitation of the structure by epoxy grouting**

Owner: Ente Autonomo del Flumendosa  
Designer: Lombardi Engineering Ltd  
Main Contractor: Gruppo Dipenta Costruzioni S.p.A.  
Specialist Contractor: Rodio S.p.A.

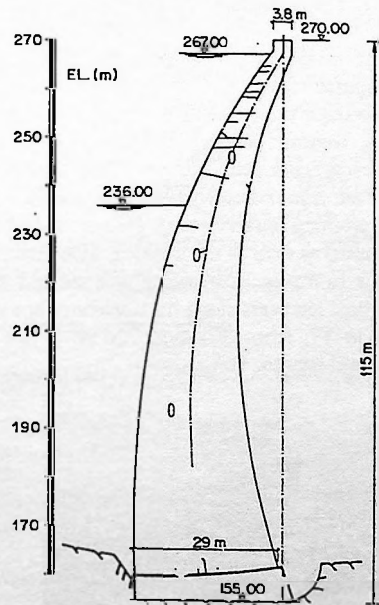
Fig 1. General layout of the dam

The double curvature Nuraghe Arrubiu arch dam on the Flumendosa river in Sardinia, 115 m high, was completed on 1957. It is founded on sound porphyritic gneiss's rock of quite satisfactory geomechanical properties. The nearly symmetrical dam was cast in 24 approx. 12 m wide blocks. Fig. 1 shows the structure's cross section.

Already at final construction stage and immediately after, a great number of horizontal cracks appeared on the upper part of the upstream face. The phenomenon slowed down progressively and since 1971 no new cracks were detected. Up to date the reservoir was only partially impounded, to about 30 m below the maximum operational water level.

The causes of the cracking, which were clearly identified through a classical structural analysis including a detailed simulation of the construction phases, consist mainly in an unacceptable state of stress due to the temperature fields in the structure during and after construction.

Consequently, as the causes are related only to the construction phase and not acting any longer, the rehabilitation project could consist in restoring a monolithic structure by grouting the cracks in using a suitable well defined technology.
